Field Report

North Hampton Public Library

Project No: 13-020-00

Field Report No: 002

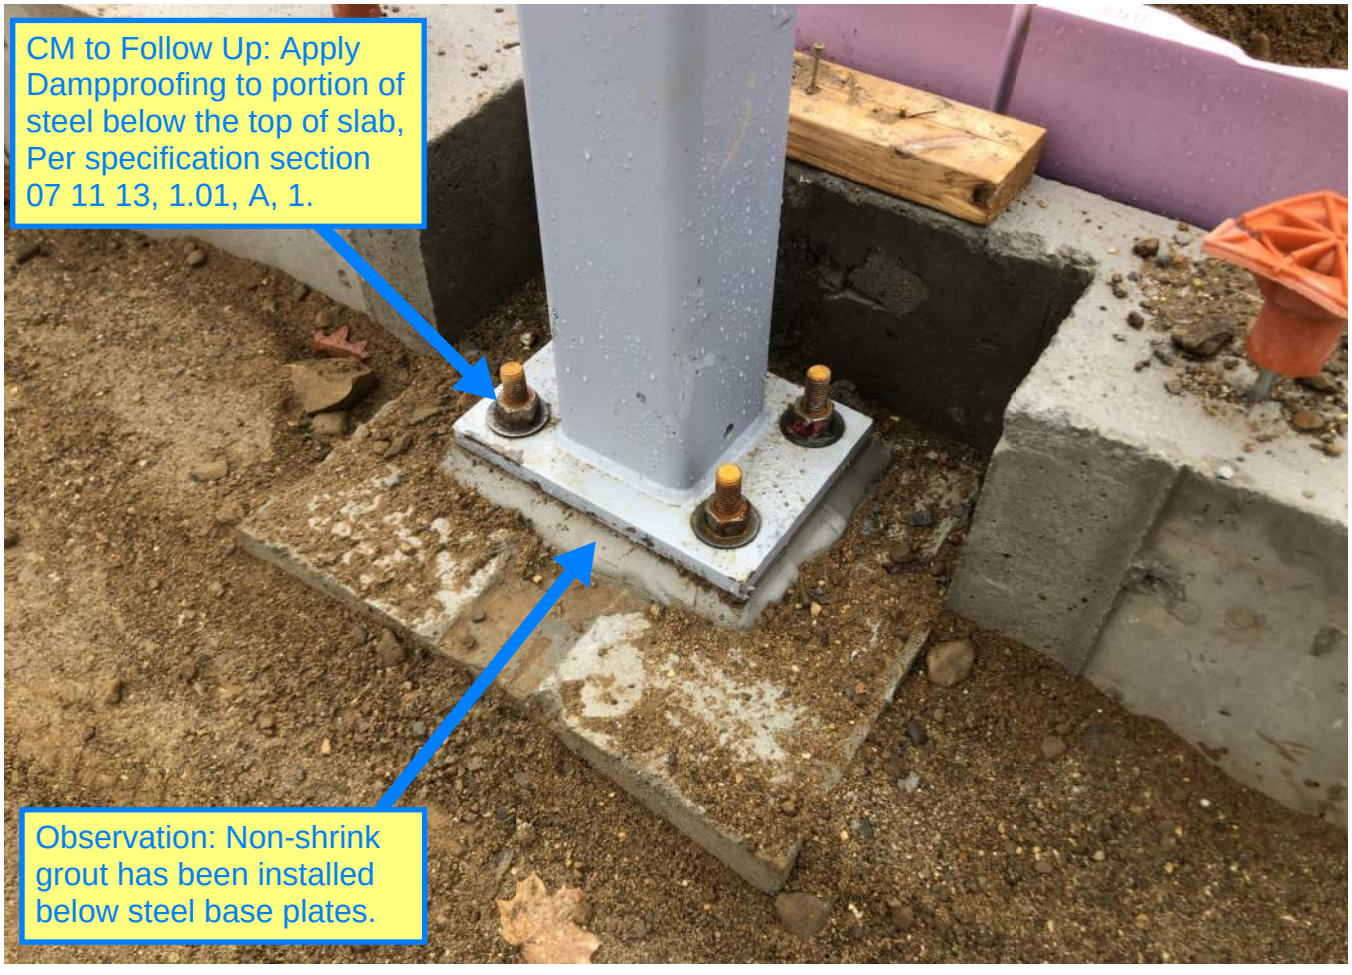
Observation: Steel Framing Installation is complete and ready for inspection.
