Field Report

North Hampton Public Library

Project No: 13-020-00

Field Report No: 002

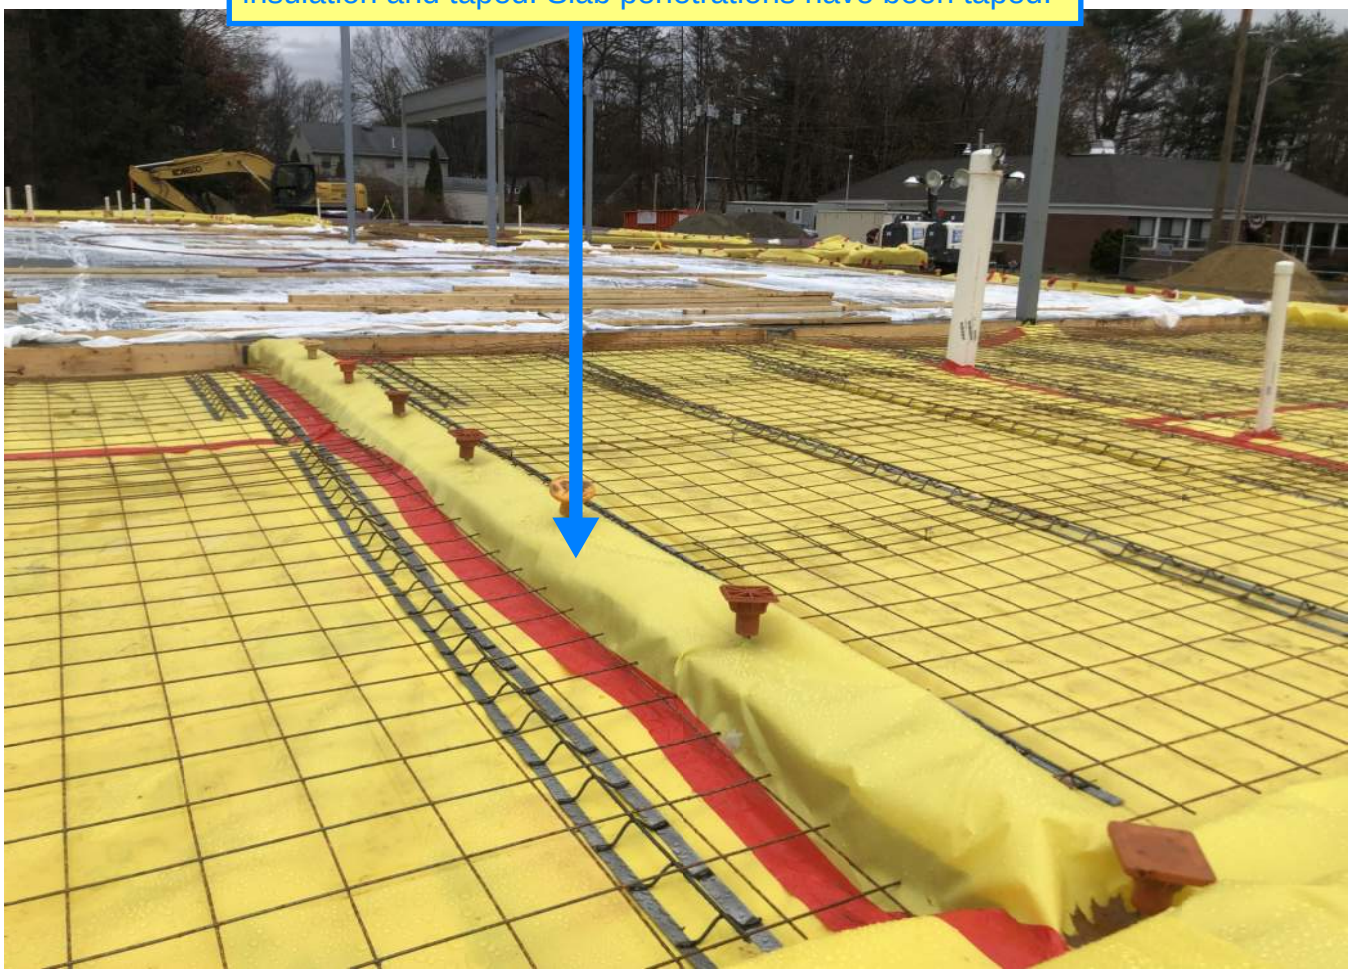
4. Observation: Vapor Barrier installed above underslab insulation and taped. Slab penetrations have been taped.

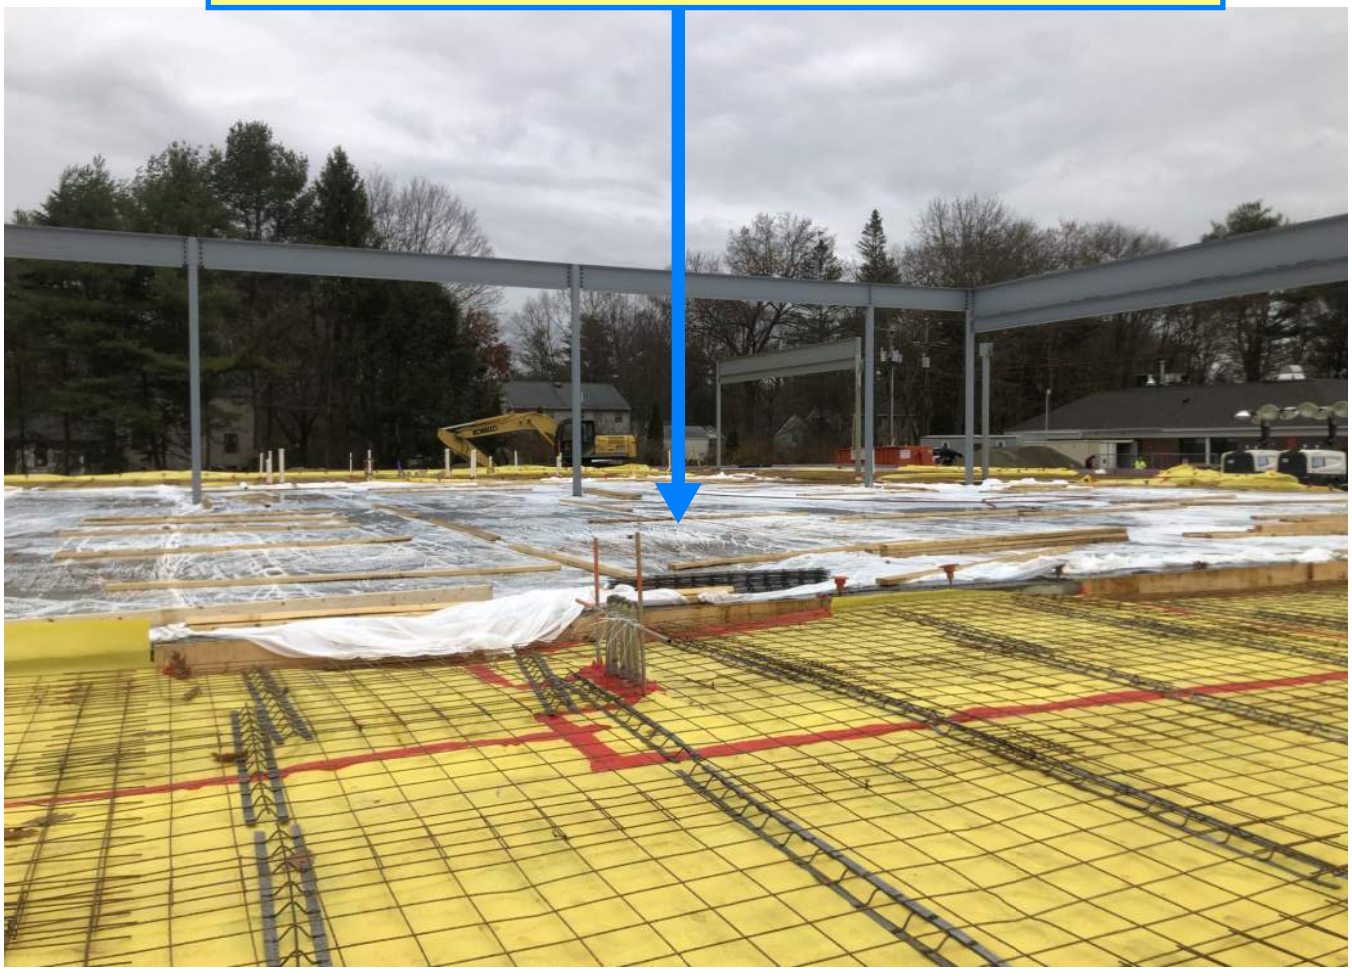
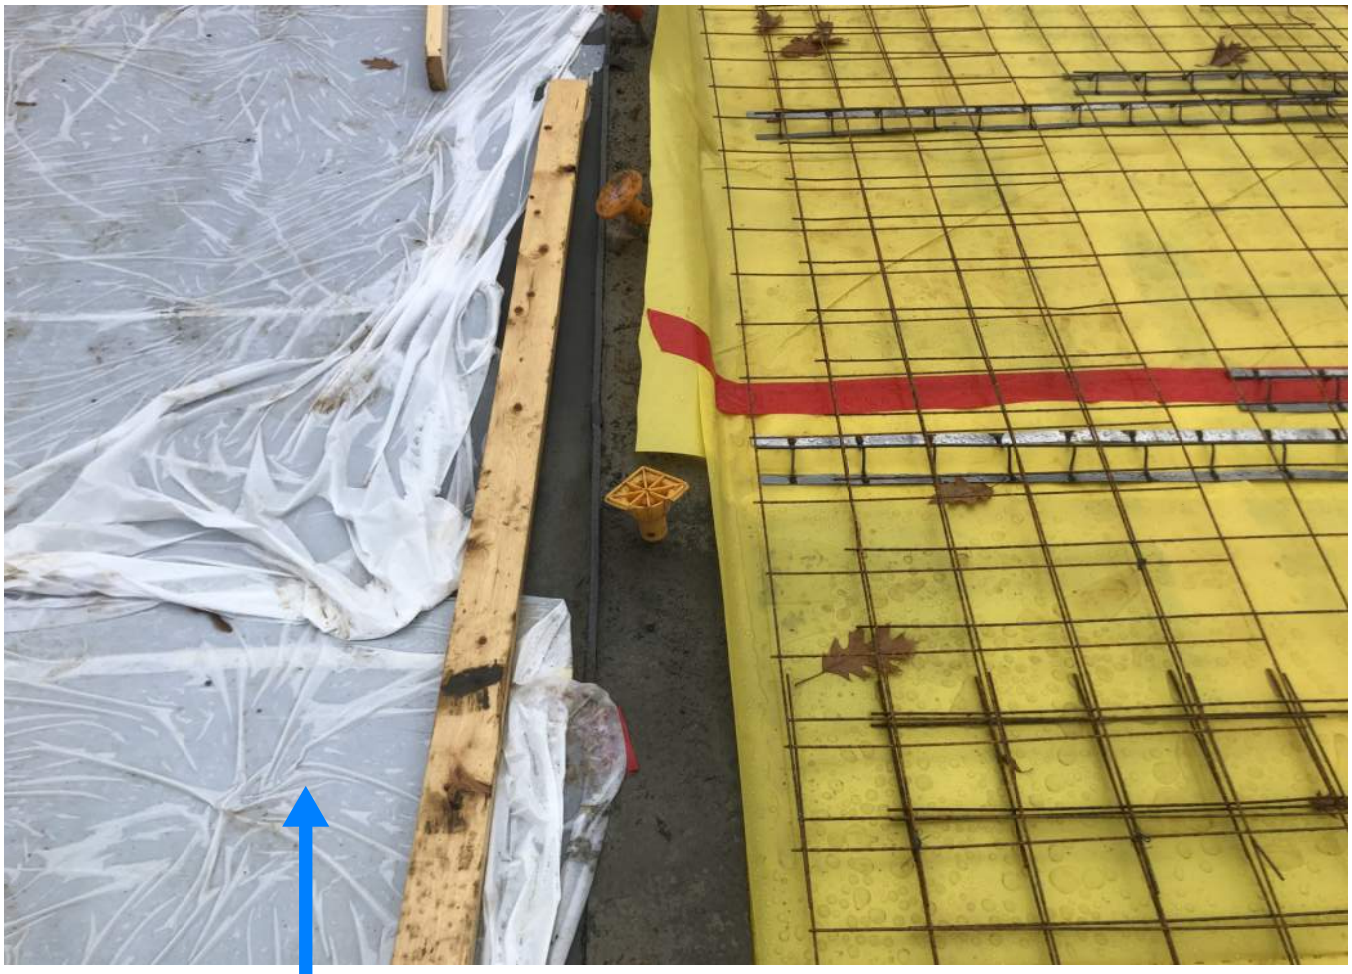
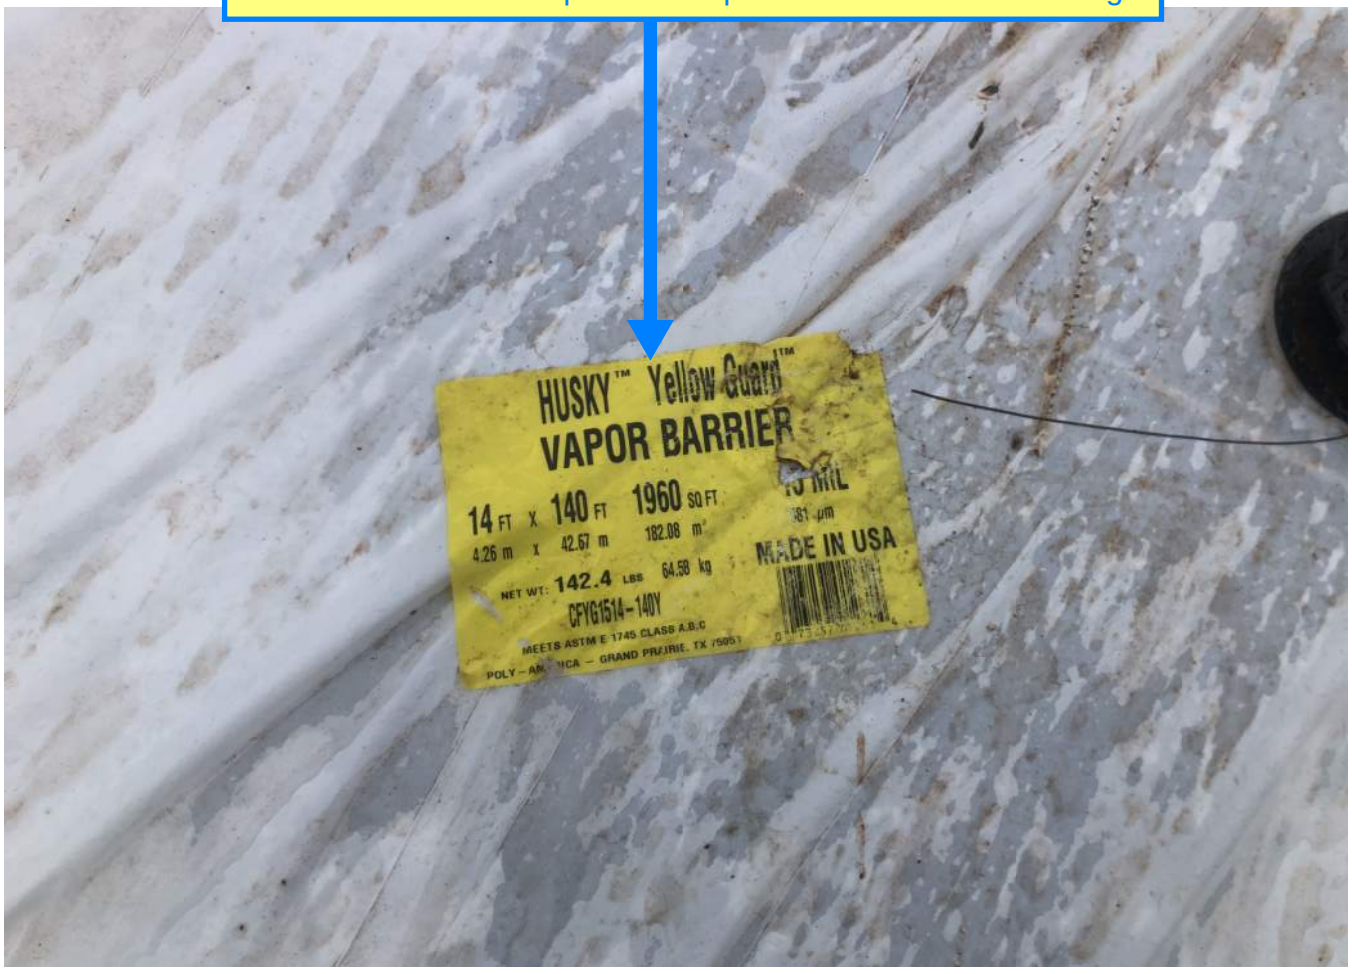
7. Observation: 5" slab placed first, then 4" slabs. Control joints have been saw-cut. Vapor Barrier placed above slab for curing.

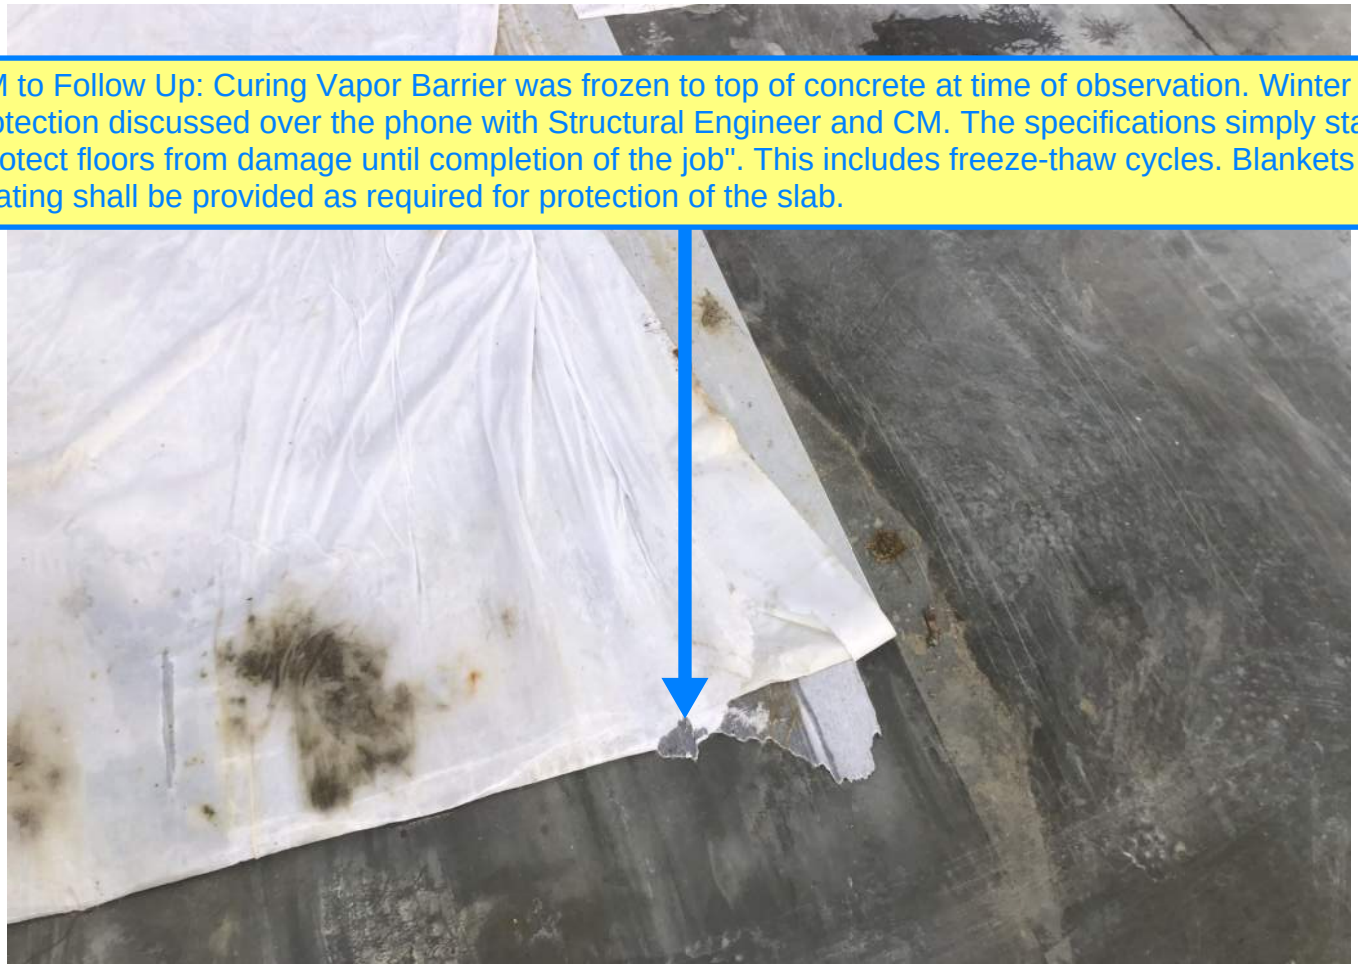
10. Observation: Double-angle door sill is flush with concrete.

11. CM to Follow Up: Curing Vapor Barrier was frozen to top of concrete at time of observation. Winter protection discussed over the phone with Structural Engineer and CM. The specifications simply state "protect floors from damage until completion of the job". This includes freeze-thaw cycles. Blankets and/or heating shall be provided as required for protection of the slab.

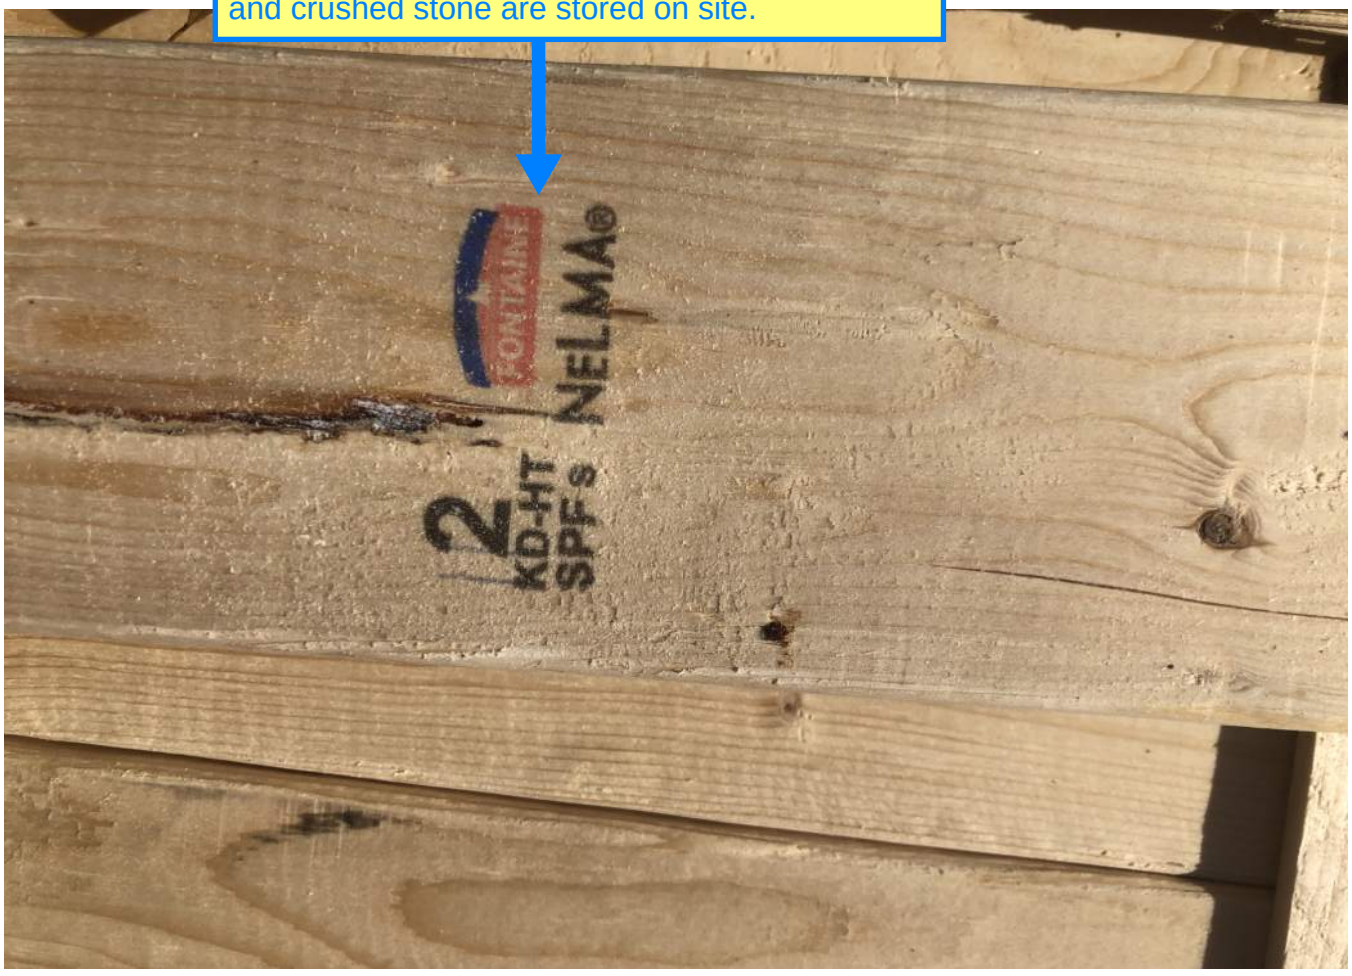
14. Observation: Lumber, Retention Structures, and crushed stone are stored on site.
